CENTRAL INTELLIGENCE AGENCY
INFORMATION REPORT

1. Our ship was in Fortaleza in February 1954 at which time we unloaded, among other things, heavy equipment for a power plant to be constructed in that area. I was able to make the following observations.

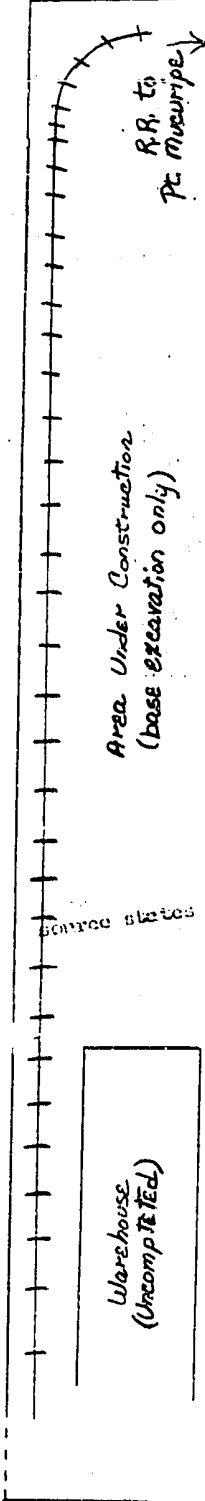
FORTALEZA, BRAZIL
Soundings Taken 2/1/54, reduced
to approximately level Mean
Low Water Springs.

- b. Pier and Dock Facilities: The pier at Mucuripe, shown on Hydrographic Office Chart #1163 running 211° to 031° , presently has a face 426 meters long. It is planned to eventually extend this pier to a length of 2,400 meters with a depth of 27 feet alongside. The pilot reports that the present depth February 1954 alongside is 18 feet. At present February 1954 only three ships can dock at a time. This makes it necessary for 70 per cent of the ships using the port to anchor about 500 yards from shore and discharge cargo into lighters. There are seven cranes on the pier, but they can only lift up to 10 tons. A ship has to use her own cranes to discharge any heavy lifts. There is a small gauge railroad track about six feet from the edge of the pier. During our visit, railroad cars were pushed by hand when empty and by truck when loaded. As is shown on figure (1), there is one uncompleted warehouse on the pier.

- h. Repair Facilities: There are sufficient facilities for most repairs not requiring a drydock.
- i. Soundings made at Dockside: The soundings shown on figure (1) show very little water on the inside of the vessel. However, I definitely recall these soundings were taken from the wharf and that the bank no doubt falls away steeply to the outer soundings.
